Subject: Department of Natural Resources Washington Geological Survey,
School Seismic Safety Assessment Project, Contract No. AE 410 -
Seismic Evaluation for **Sunnyside School District**

1. Outlook Elementary School, Outlook Elementary School Main Building

1.1 Building Description

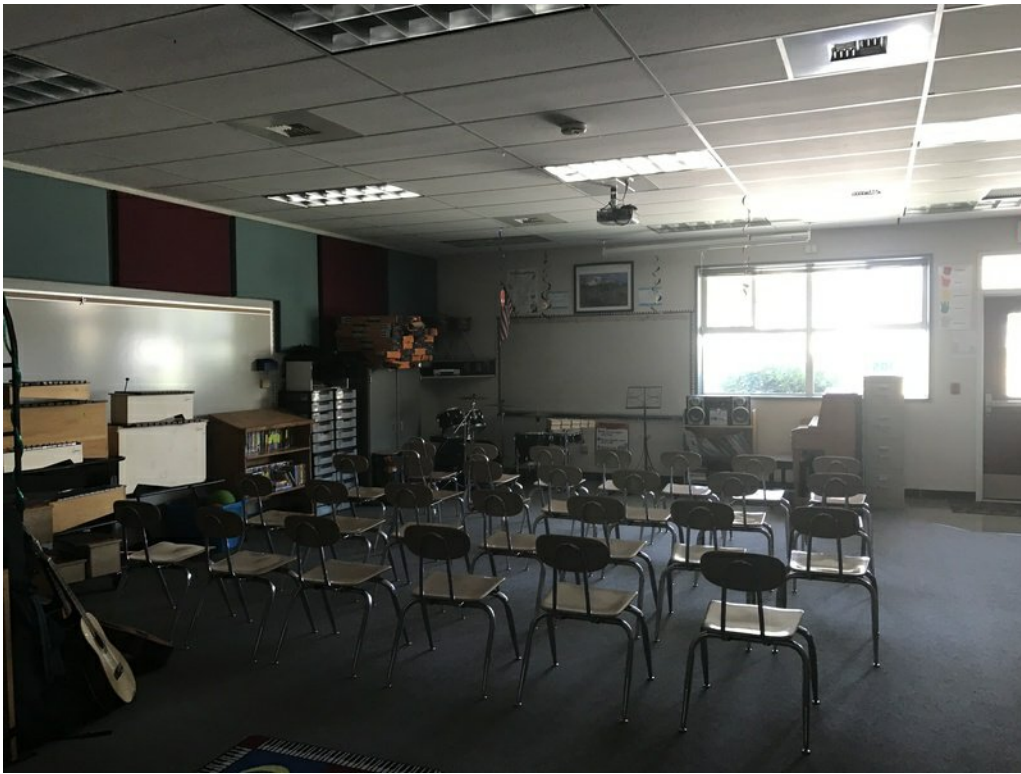
Figure 1-2. Typical Classroom with Unknown Light Fixture Bracing

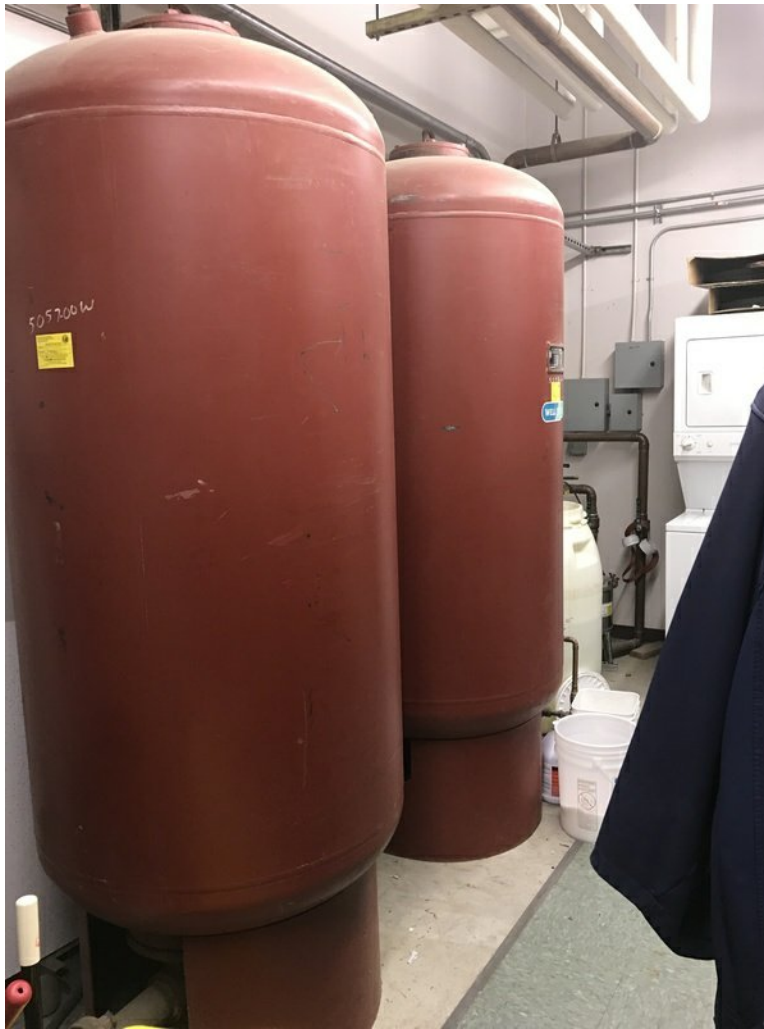
Figure 1-3. Unbraced MEP Equipment, Typical Throughout

M-3 Weakened Planes. HR-not required; LS-LMH; PR-LMH.	Further investigation required to verify anchorage of masonry veneer at weakened planes.
ME-2 In-Line Equipment. HR-not required; LS-H; PR-H.	This evaluation could not be visually verified. Further investigation is required to review vertical support and lateral bracing of equipment.

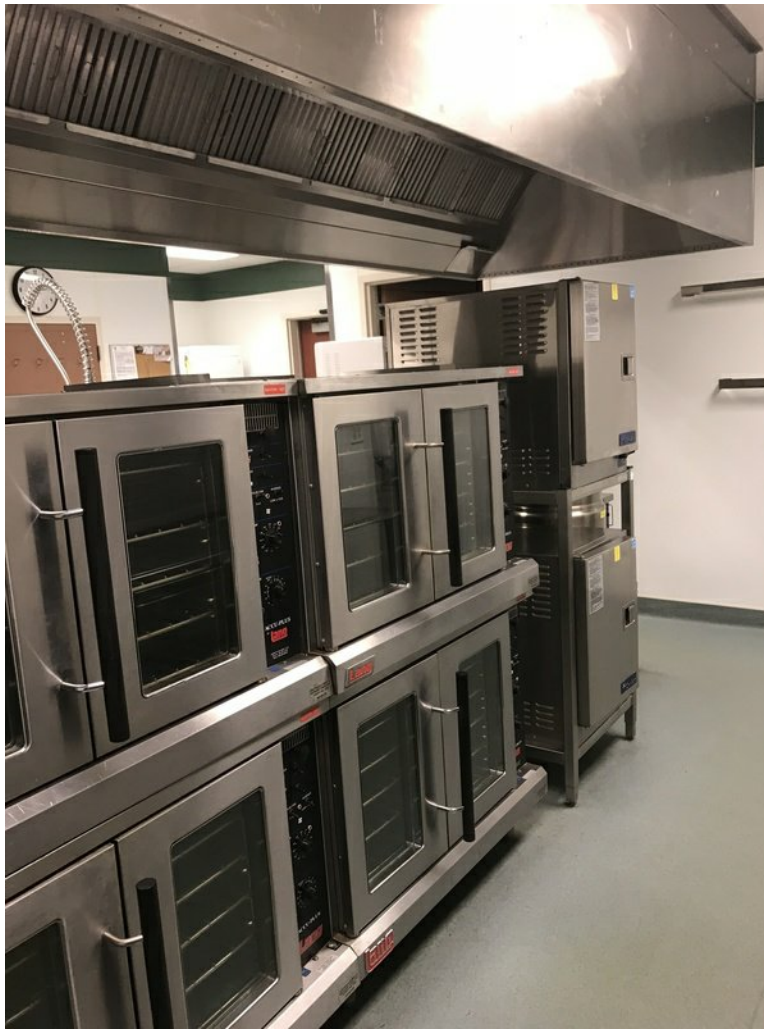
Figure 1-4. Unbraced Nonstructural Components, Typical Throughout

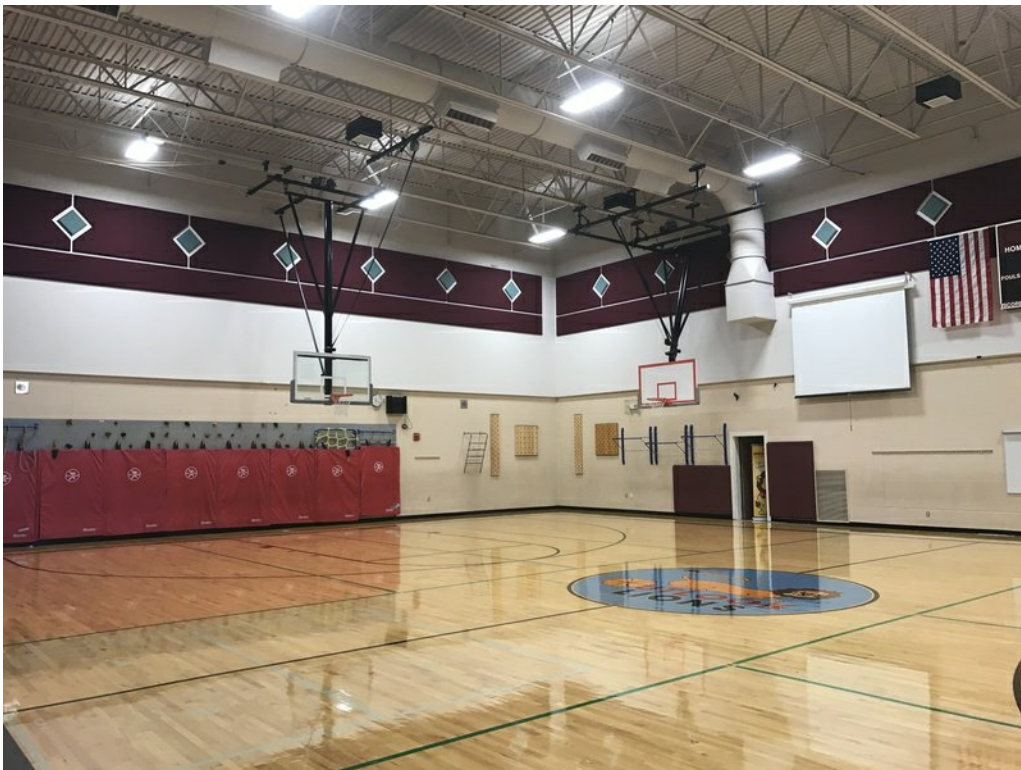
Figure 1-7. Gymnasium with Steel Joists and Metal Roof Deck
